Haile Gold Mine, Inc.

**Spring 2012 Aquatic Resource
Surveys Report**

June 19, 2012

Spring 2012 Aquatic Resource Surveys Report

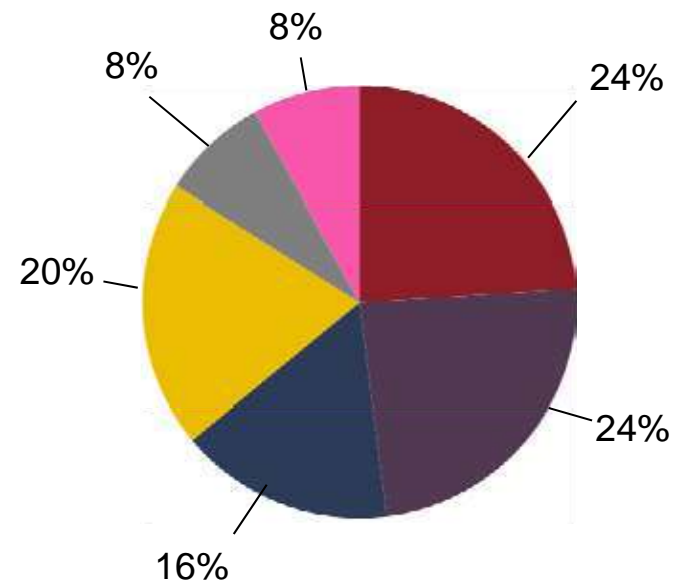
The channel inorganic substrate is composed primarily of sandy-silt (approximately 24% sand and 16% silt) with some gravel (24%) (Figure 3-2). LWD, undercut banks and root mats, were mostly absent within this reach. LWD estimates determined at HGMC4 were low compared to other reaches ($3.1 \times 10^5 \text{ ft}^2/\text{mi}^2$). Moderate deposits of sand were observed within this sample reach, and the marginal increases in bar formation observed were composed primarily of gravel. Within the shallow pool habitats, sediment deposition was minimal.

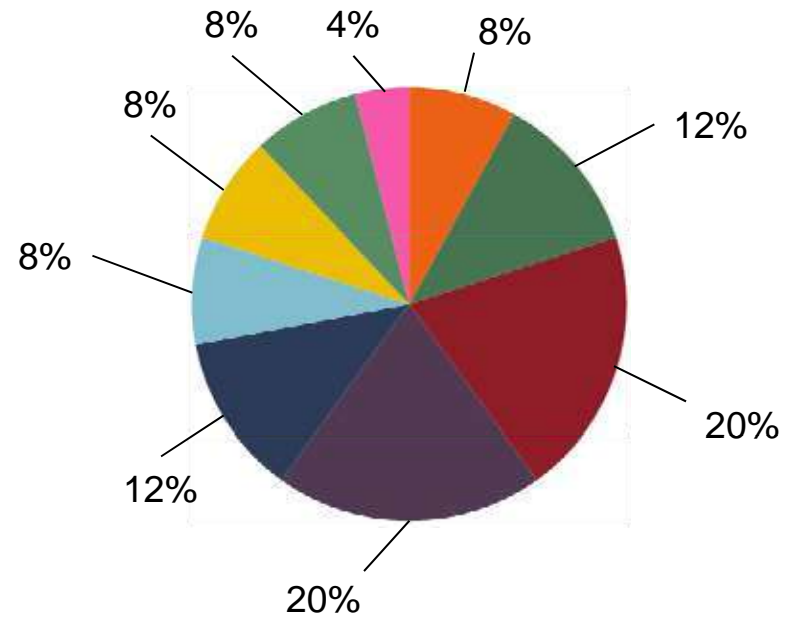
FIGURE
3-3

Channel inorganic substrate is composed primarily of sandy-silt (approximately 24% sand and 24% silt) (Figure 3-3). An abundance of CPOM (32%), including leaf litter and sticks, was also present in the stream reach. LWD was moderately abundant, with an estimated LWD density ($4.7 \times 10^5 \text{ ft}^2/\text{mile}^2$). Shallow run (50%) and pool (50%) habitats were the major stream morphology types observed within this reach. During the habitat assessment, baseflow was low to moderate (on average, water filled only about 75% of the available channel). As a result, some substrates were exposed. Four species of aquatic vegetation were observed including *Murdannia kiesak* and *Sparganium americanum*. In addition, a small amount of green filamentous algae was observed on the substrate. Aquatic vegetation occurred within approximately 4% of the reach.

matter (FPOM) (a combined 16%) and aquatic vegetation (Figure 3-3). Four species of aquatic vegetation were observed including *Murdannia kiesak* and *Sparganium americanum*. In addition, a small amount of green filamentous algae was observed on the substrate. Aquatic vegetation occurred within approximately 30% of the reach.

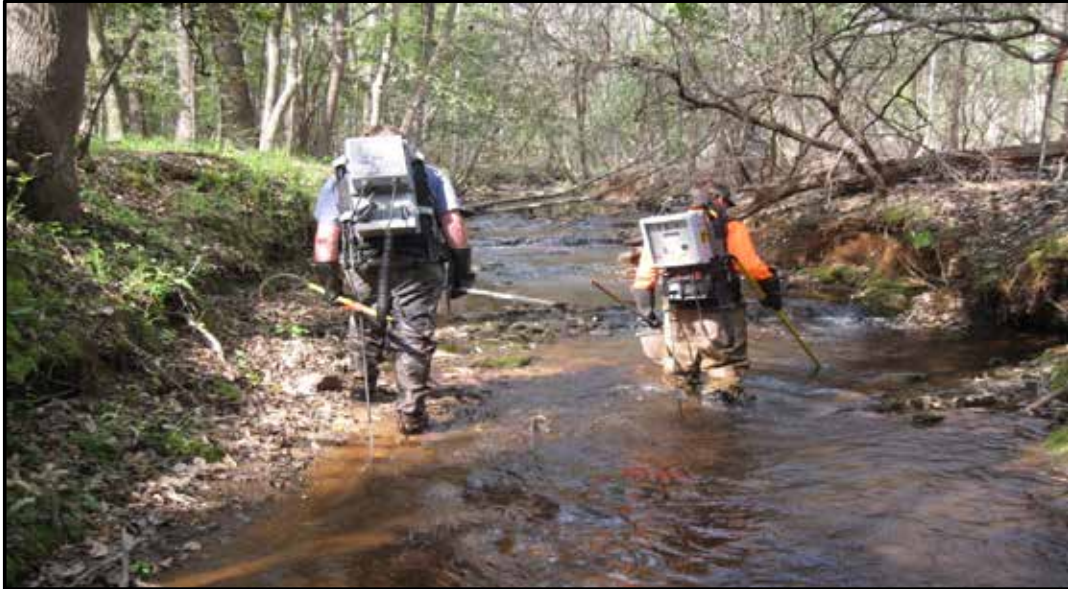
1

Electrofishing in reach MFS6 in Camp Branch

A survey crew of five biologists used Smith-Root backpack electrofishing units and two netters to collect target migratory fish species. Any migratory fish species observed were retained for length measurement and photographed prior to release. All observed migratory fish data obtained per study reach was recorded in the field notebook. Resident fish species were not collected during electrofishing to avoid any unnecessary trauma related to handling. A representative photo of electrofishing, showing the equipment used, is provided in Appendix A as Photo #1.

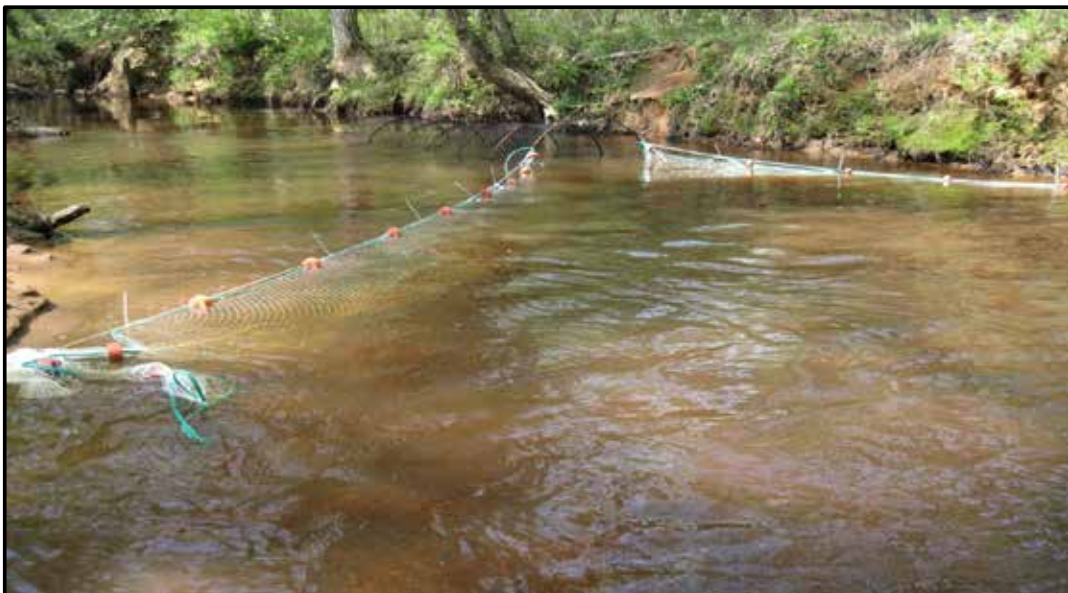
2

Fyke net in reach MFS3 in the Little Lynches River

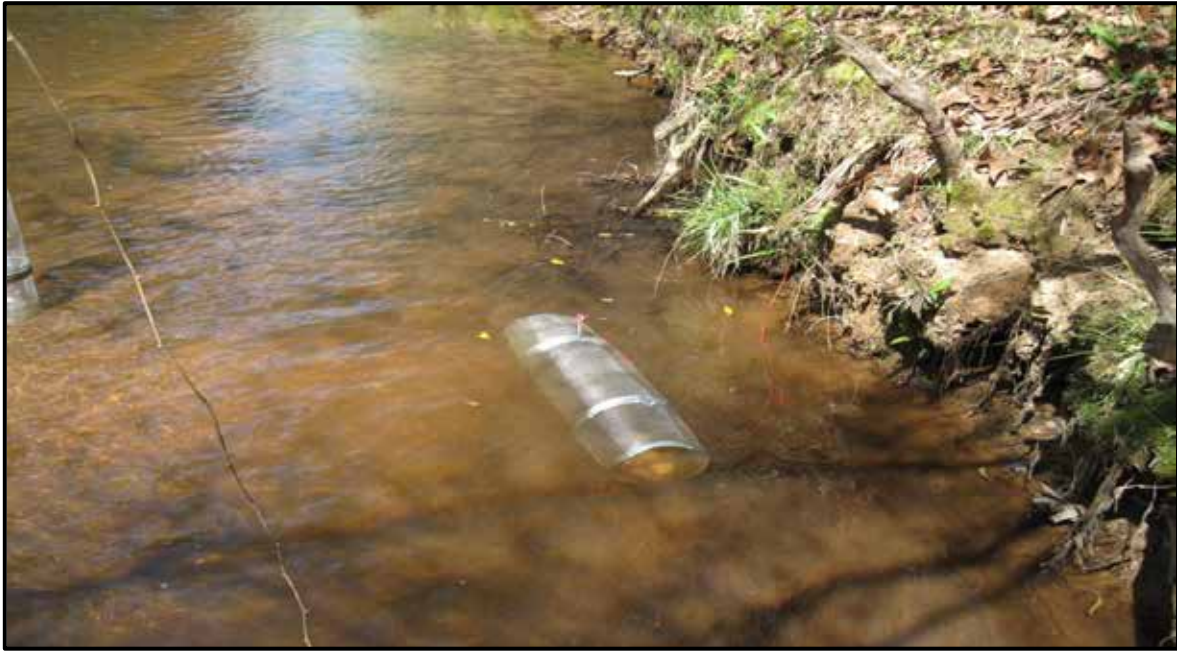
3

Gee® Eel Trap in reach MFS2 in the Little Lynches River

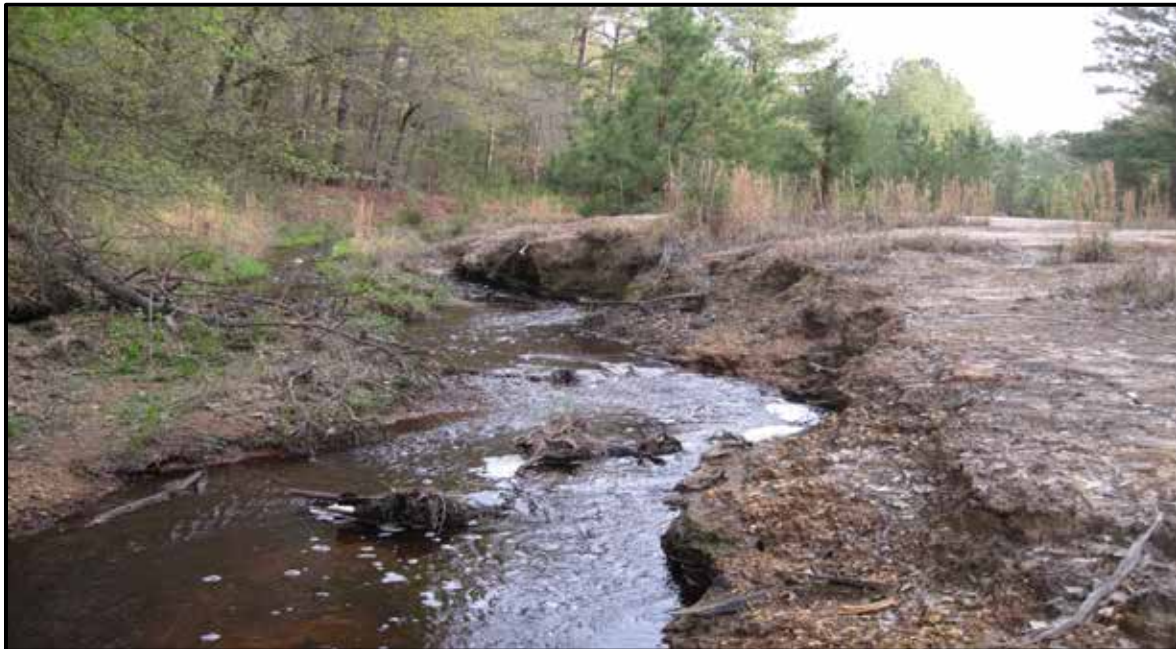
15

- MFS4 – This location in Haile Gold Mine Creek consisted of shallow water (less than approximately 2-ft deep) with a sequence of riffles, runs, and pools (Appendix A - Photos #16 and #17). Water quality parameters are presented in Table 2-2. No migratory fish species were observed in either sampling event.

Reach MFS4 in Haile Gold Mine Creek looking upstream from the middle of the reach

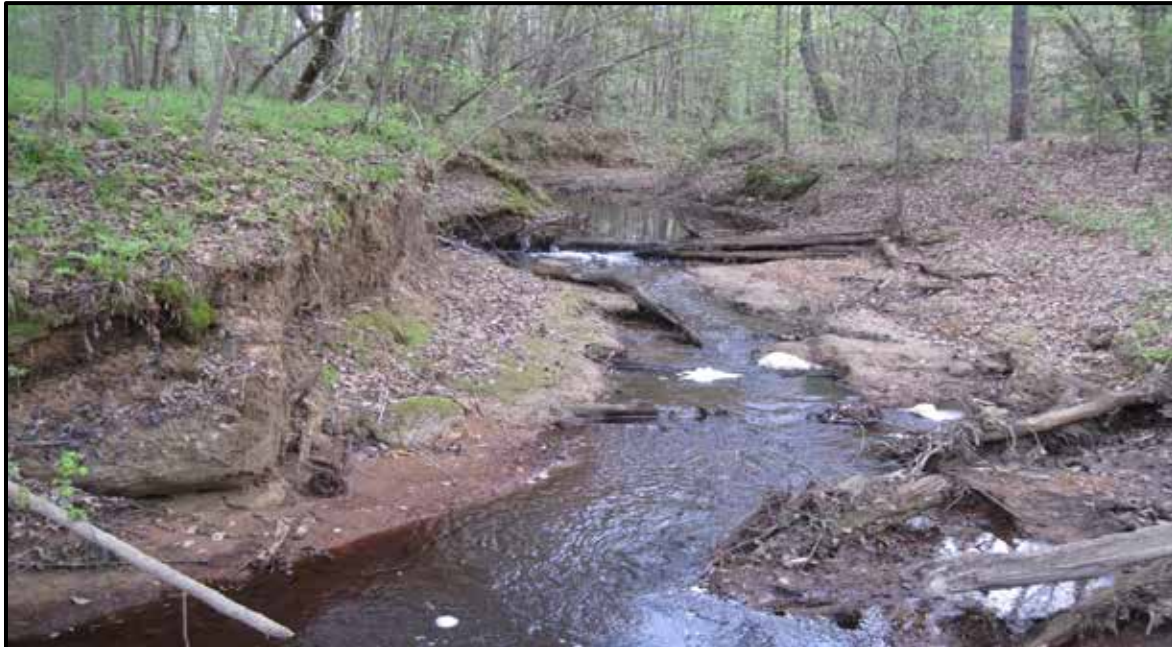
17

Reach MFS4 in Haile Gold Mine Creek looking downstream from upstream

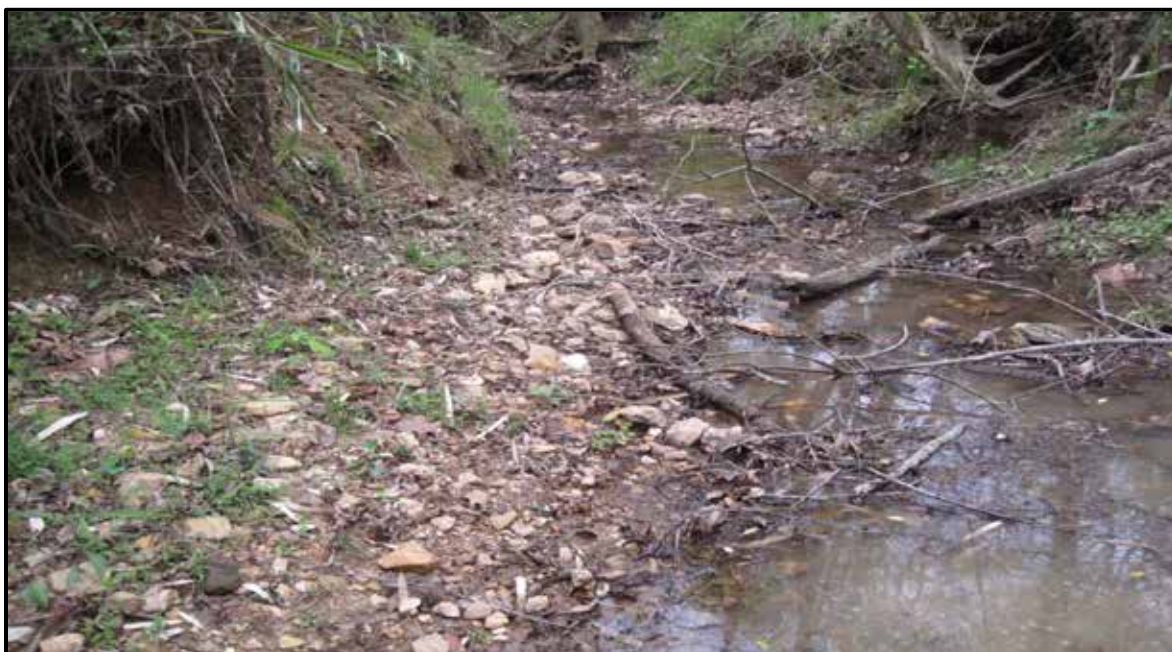
18

- MFS5 – This location in Champion Branch consisted of very shallow water (less than 3-inches deep) with soft substrates and organic debris (Appendix A - Photos #18 and #19). Water quality parameters are presented in Table 2-2. No migratory fish species were observed during either sampling event.

Reach MFS5 in Champion Branch looking upstream from the middle of the reach

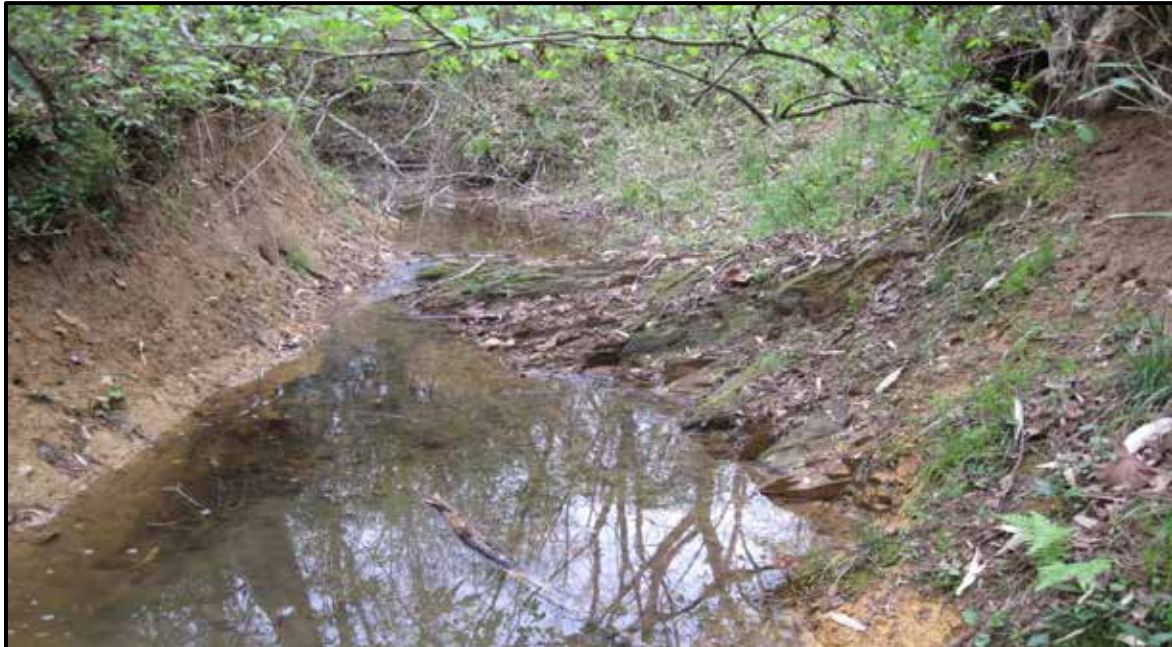
19

Reach MFS5 in Champion Branch looking upstream from downstream

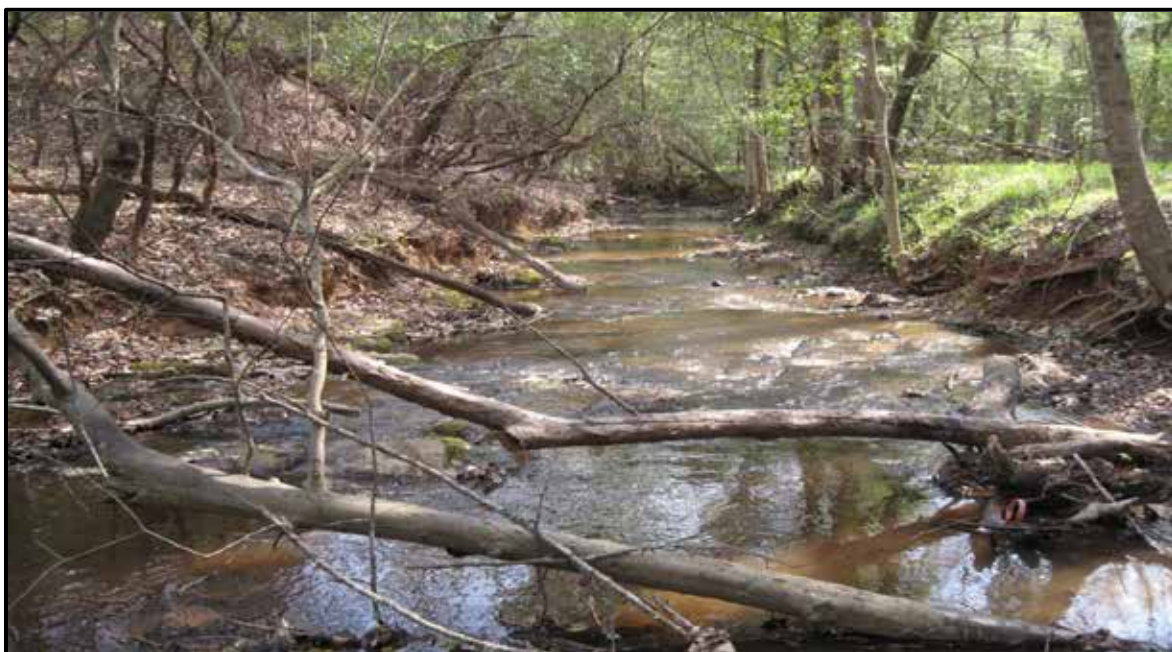
20

- MFS6 – This location in Camp Branch consisted of shallow water (less than 1-ft deep) with a sequence of riffles, runs, and small pools (Appendix A - Photos #20 and #21). Water quality parameters for this location are presented in Table 2-2. No migratory fish species were observed in either sampling event.

Reach MFS6 in Camp Branch looking downstream from the middle of the reach

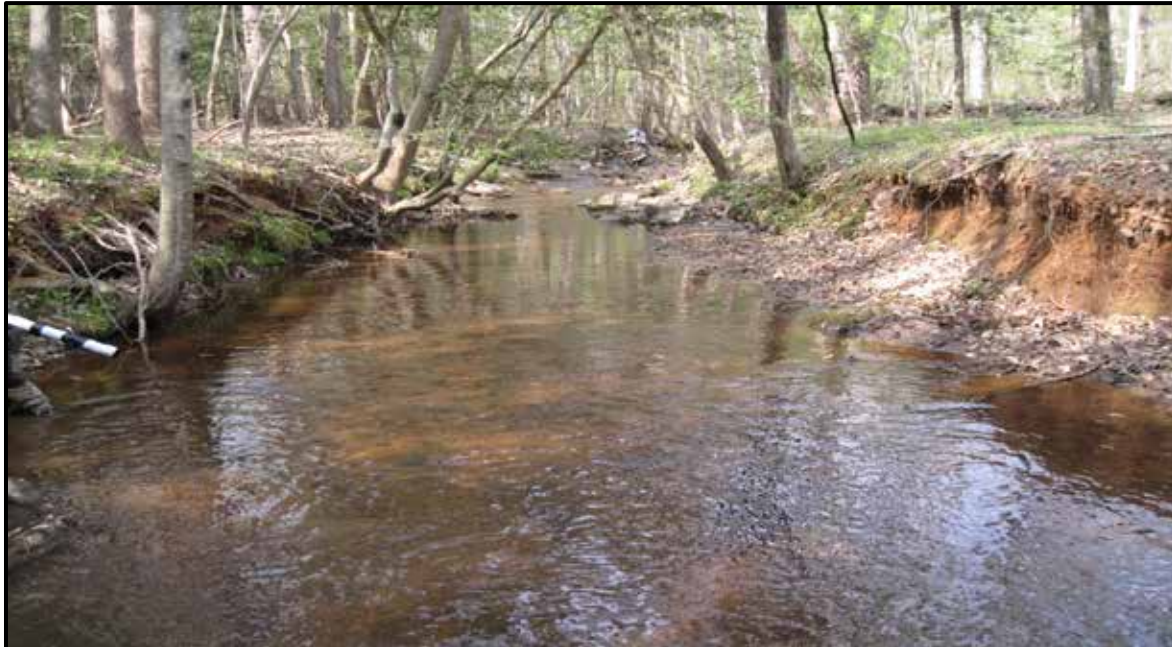
21

Reach MFS6 in Camp Branch looking upstream from downstream

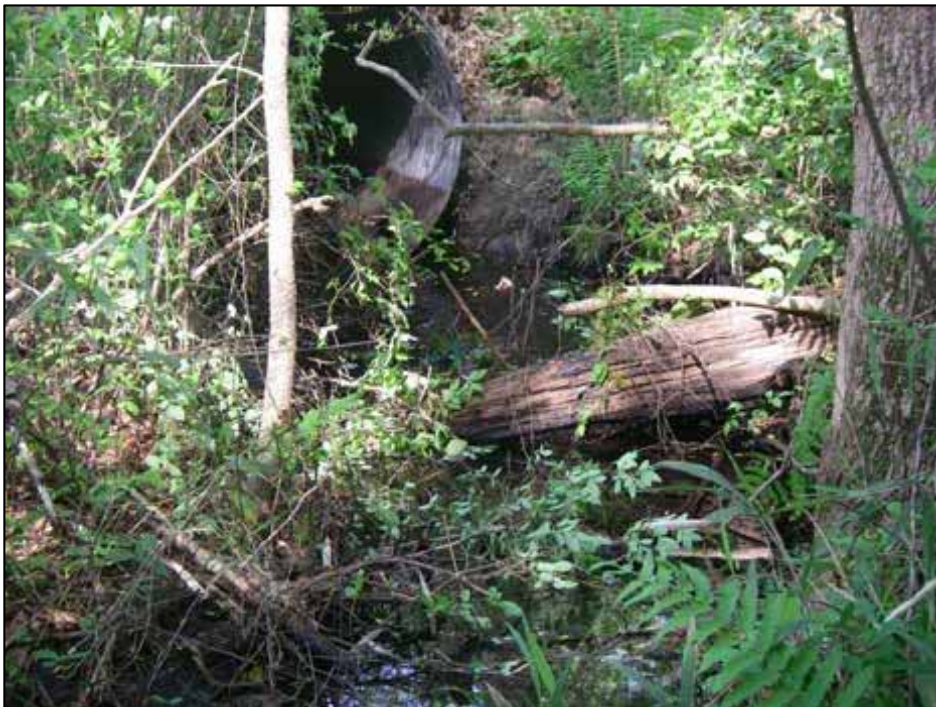
Photograph #2.
Haile Gold Mine Creek (HGMC3)
– Culvert at the upstream end of
the sample reach.

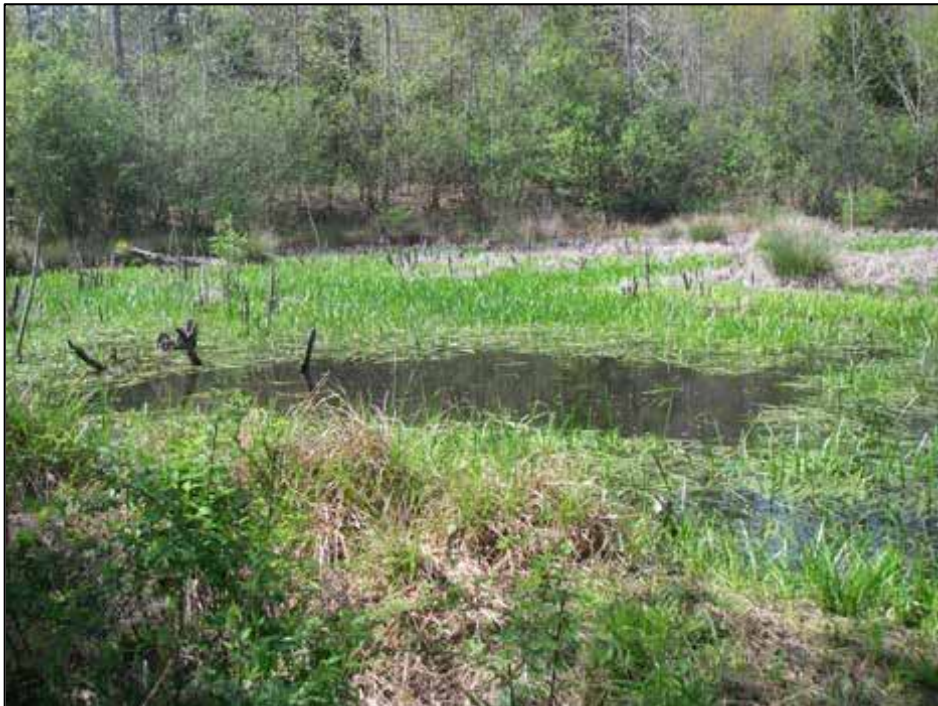
Photograph #8.

Camp Branch (CB4) – Looking at impounded area at upstream end of sample reach.

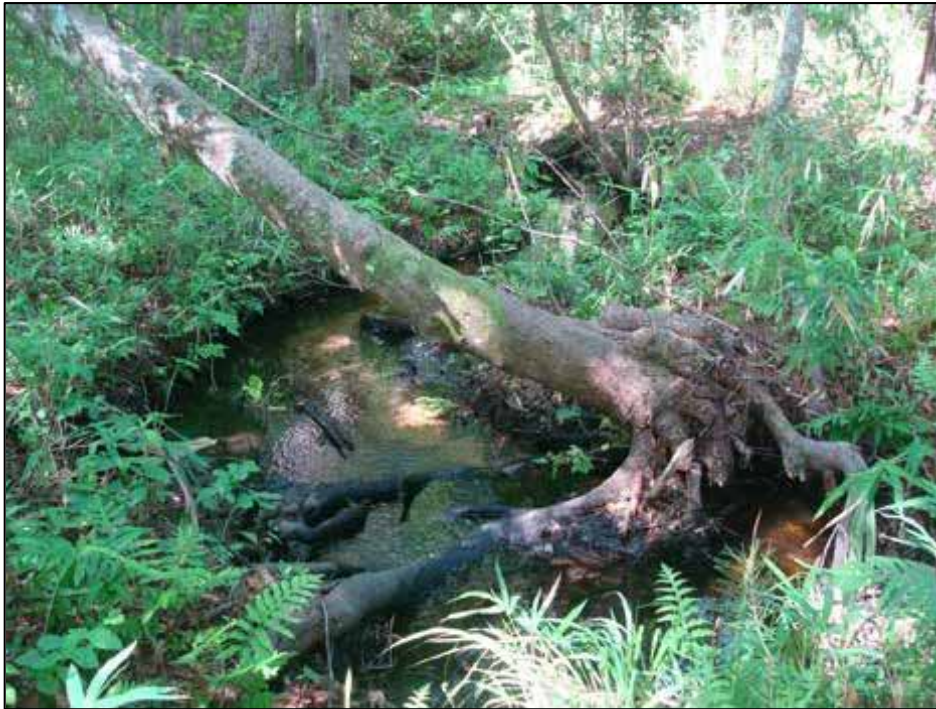
Photograph #13.
Haile Gold Mine Creek (HGMC3)
– Example of natural in-stream
barrier, comprised of large root
wad.

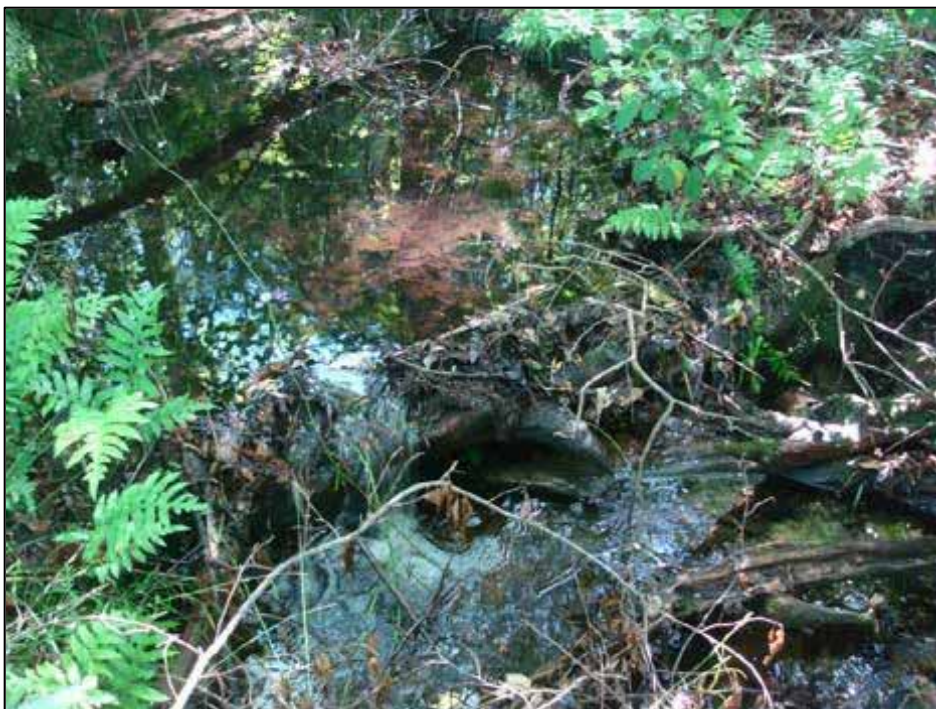
Photograph #14.
Haile Gold Mine Creek (HGMC3)
– Example of natural in-stream
barrier, comprised of assorted
small and large woody debris.

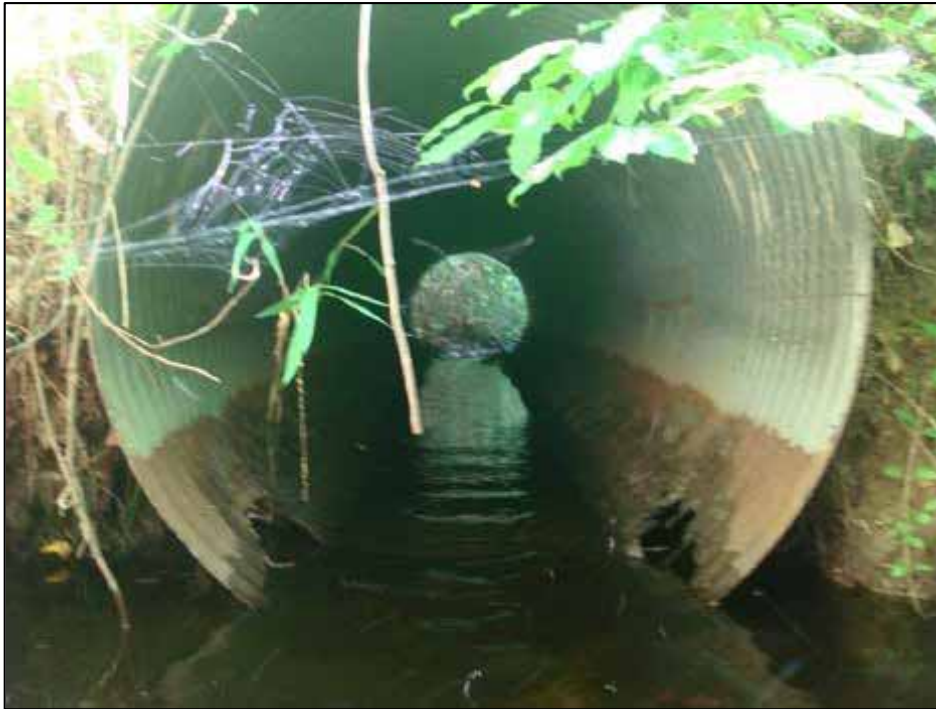
Photograph #15.
Haile Gold Mine Creek (HGMC3)
– Example of potential man-made barrier via road crossing through large culvert.

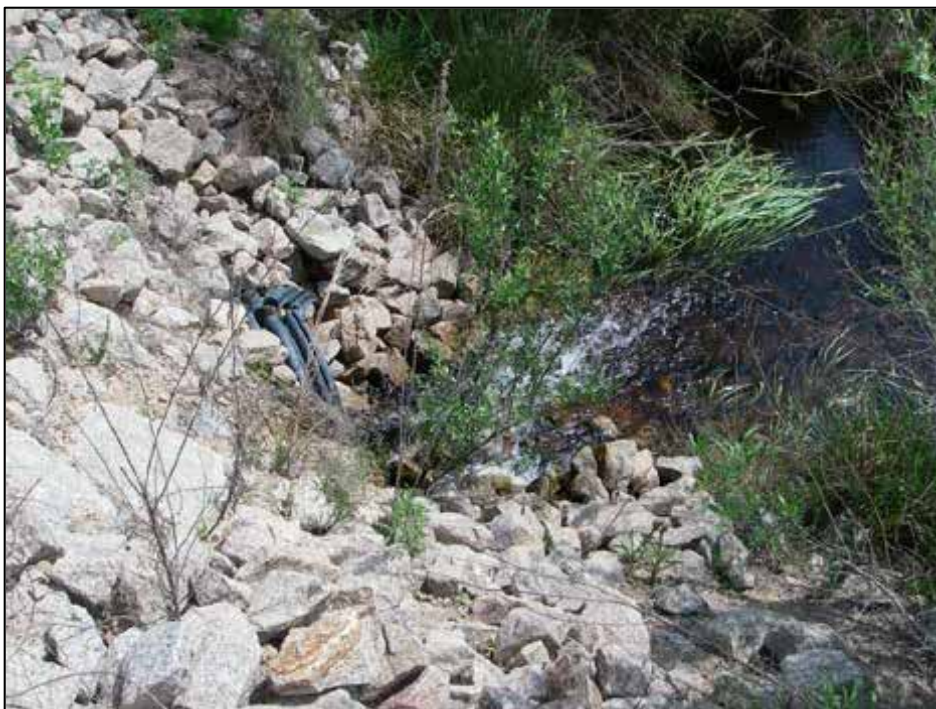
HGMC4 is located in the upper portion of HGMC, approximately 1,500 ft upstream of the Ledbetter Reservoir, and overlaps with a previous survey location (R08-3; see Figure 4-1). Between the reservoir and HGMC4 exists a road crossing (approximately 600 ft downstream of HGMC4), and two beaver dams near to HGMC5. On the day of the assessment (4/5/2011), average flow velocity was 0.68 feet per second (ft/s) and average depth was 0.92 ft. Baseflow and the corresponding wetted width (6.1 ft) reached the edge of banks throughout most of the reach. Minimal exposed substrate was observed. Stream morphology of this reach consisted of nearly all run habitat. The reach observed was within an incised channel with relatively uniform width and depth.

Photograph #16.
Haile Gold Mine Creek (Between HGMC 4 and HGMC5) – Example of potential man-made barrier via road crossing through large culvert.
